Bike Signal Resource Hub Case Study – Montgomery County, Maryland

Bike Signal Resource Hub Case Study – Montgomery County, MD

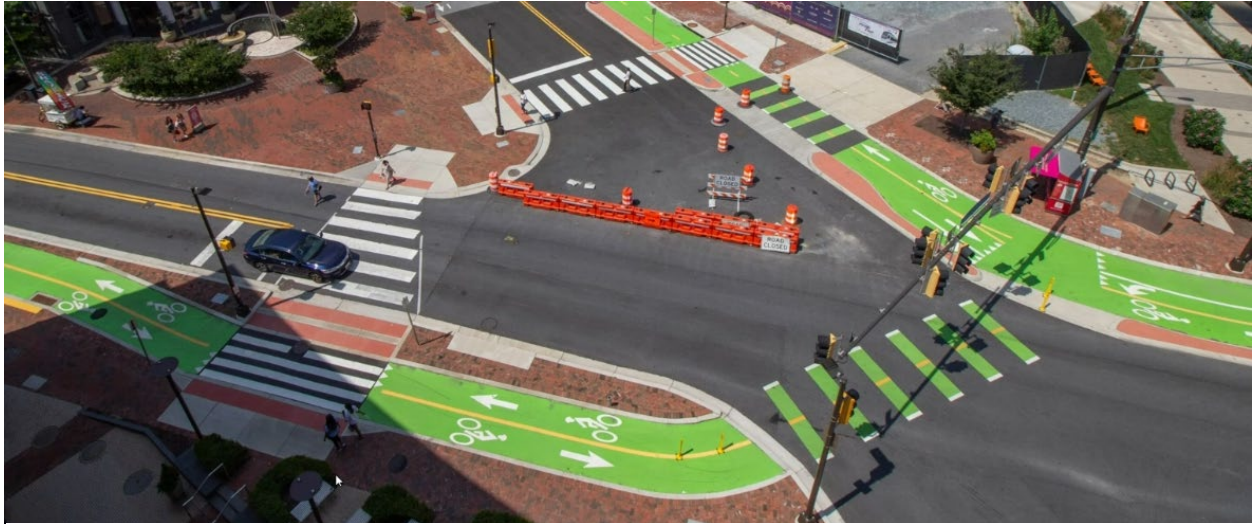
Figure 1. Bethesda at Woodmont, Downtown Bethesda. Source: Matt Johnson.

- Number of intersections
 - One intersection with two bike crossings (both signalized with bike signals): SW-NE (diagonal) and NE-SE (parallel to Woodmont Ave & east leg crosswalk)
- Detection type used
 - On recall for peds and bikes, but includes detection for future use (video)
- Type of bike facility and form of separation
 - Two-way cycle track application
 - Raised concrete medians
 - MMA is used for areas not driven on
- How are bicycle/vehicle/ped conflicts handled?
 - 3-phase signal
 - First N/S on Woodmont (All ped signals and bikes are red allowing turning movements for vehicles)
 - Then E/W (All ped signals and bikes are red allowing turning movements for vehicles)

- Then, all peds WALK, all Bikes Green
 - Bikes have shark's teeth markings to yield to peds
- Size of bike signal indications (4", 8", 12")?
 - Two heads for each approach, one nearside and one far side
 - All 12" heads (the County doesn't have any 8" or 4" so for stocking consistent parts)
- Key challenges/obstacles to designing and implementation?
 - Water main pole conflicts made it challenging to place poles out in the road medians
 - 3-phase signal

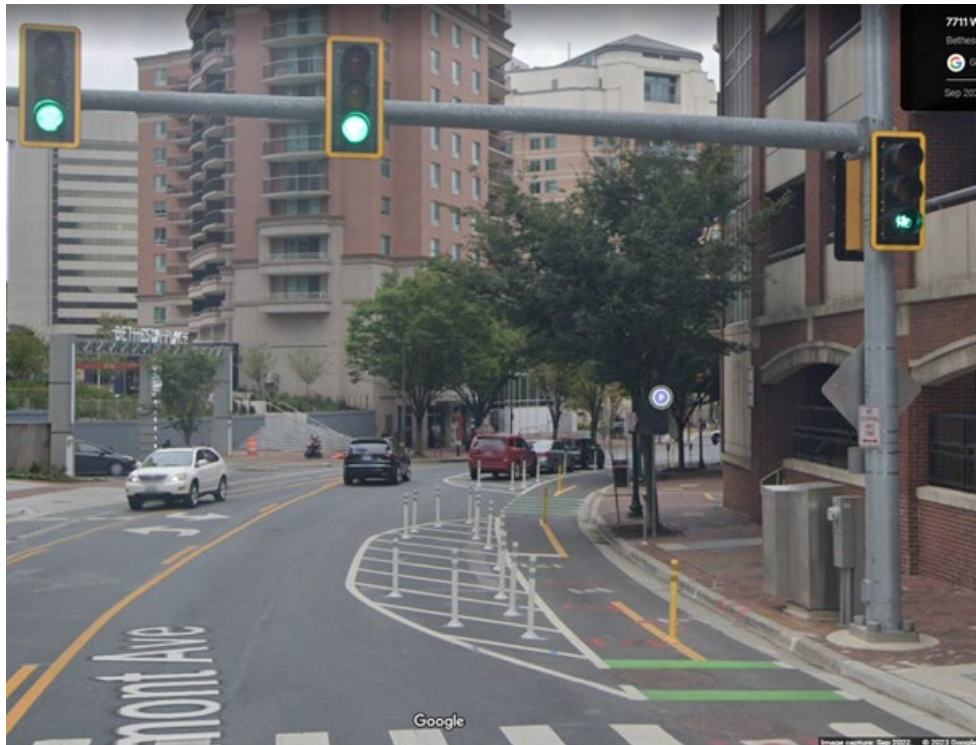
Figure 2. Woodmont Avenue, Bethesda, MD. Source: Google Street View Imagery: (9/2022, Copyright 2023.)

- Number of intersections
 - One bike signal
- Detection type used
 - Rests in green for vehicles and bikes on mainline (no ped control for mainline peds), hot response changes it to red when peds activate the crossing by pushing button
- Type of bike facility and form of separation
 - Two-way cycle track application
 - Striping/posts
 - MMA is used for areas not driven on

- How are bicycle/vehicle/ped conflicts handled?
 - Bikes & cars stop when peds go
- Size of bike signal indications (4", 8", 12")?
 - One head for each approach, one nearside and one far side
 - All 12" heads (the County doesn't have any 8" or 4" so for stocking consistent pars)
- Key challenges/obstacles to designing and implementation?
 - Was originally installed as green ball, changed to bike signals to reinforce that bikes need to stop for peds
